June 1983

Site Investigation Syosset Landfill Oyster Bay, New York

Peter M. Stokely, Imagery Analyst

**ENVIRONMENTAL MONITORING SYSTEMS LABORATORY
OFFICE OF RESEARCH AND DEVELOPMENT
U.S. ENVIRONMENTAL PROTECTION AGENCY
LAS VEGAS, NEVADA 89114**

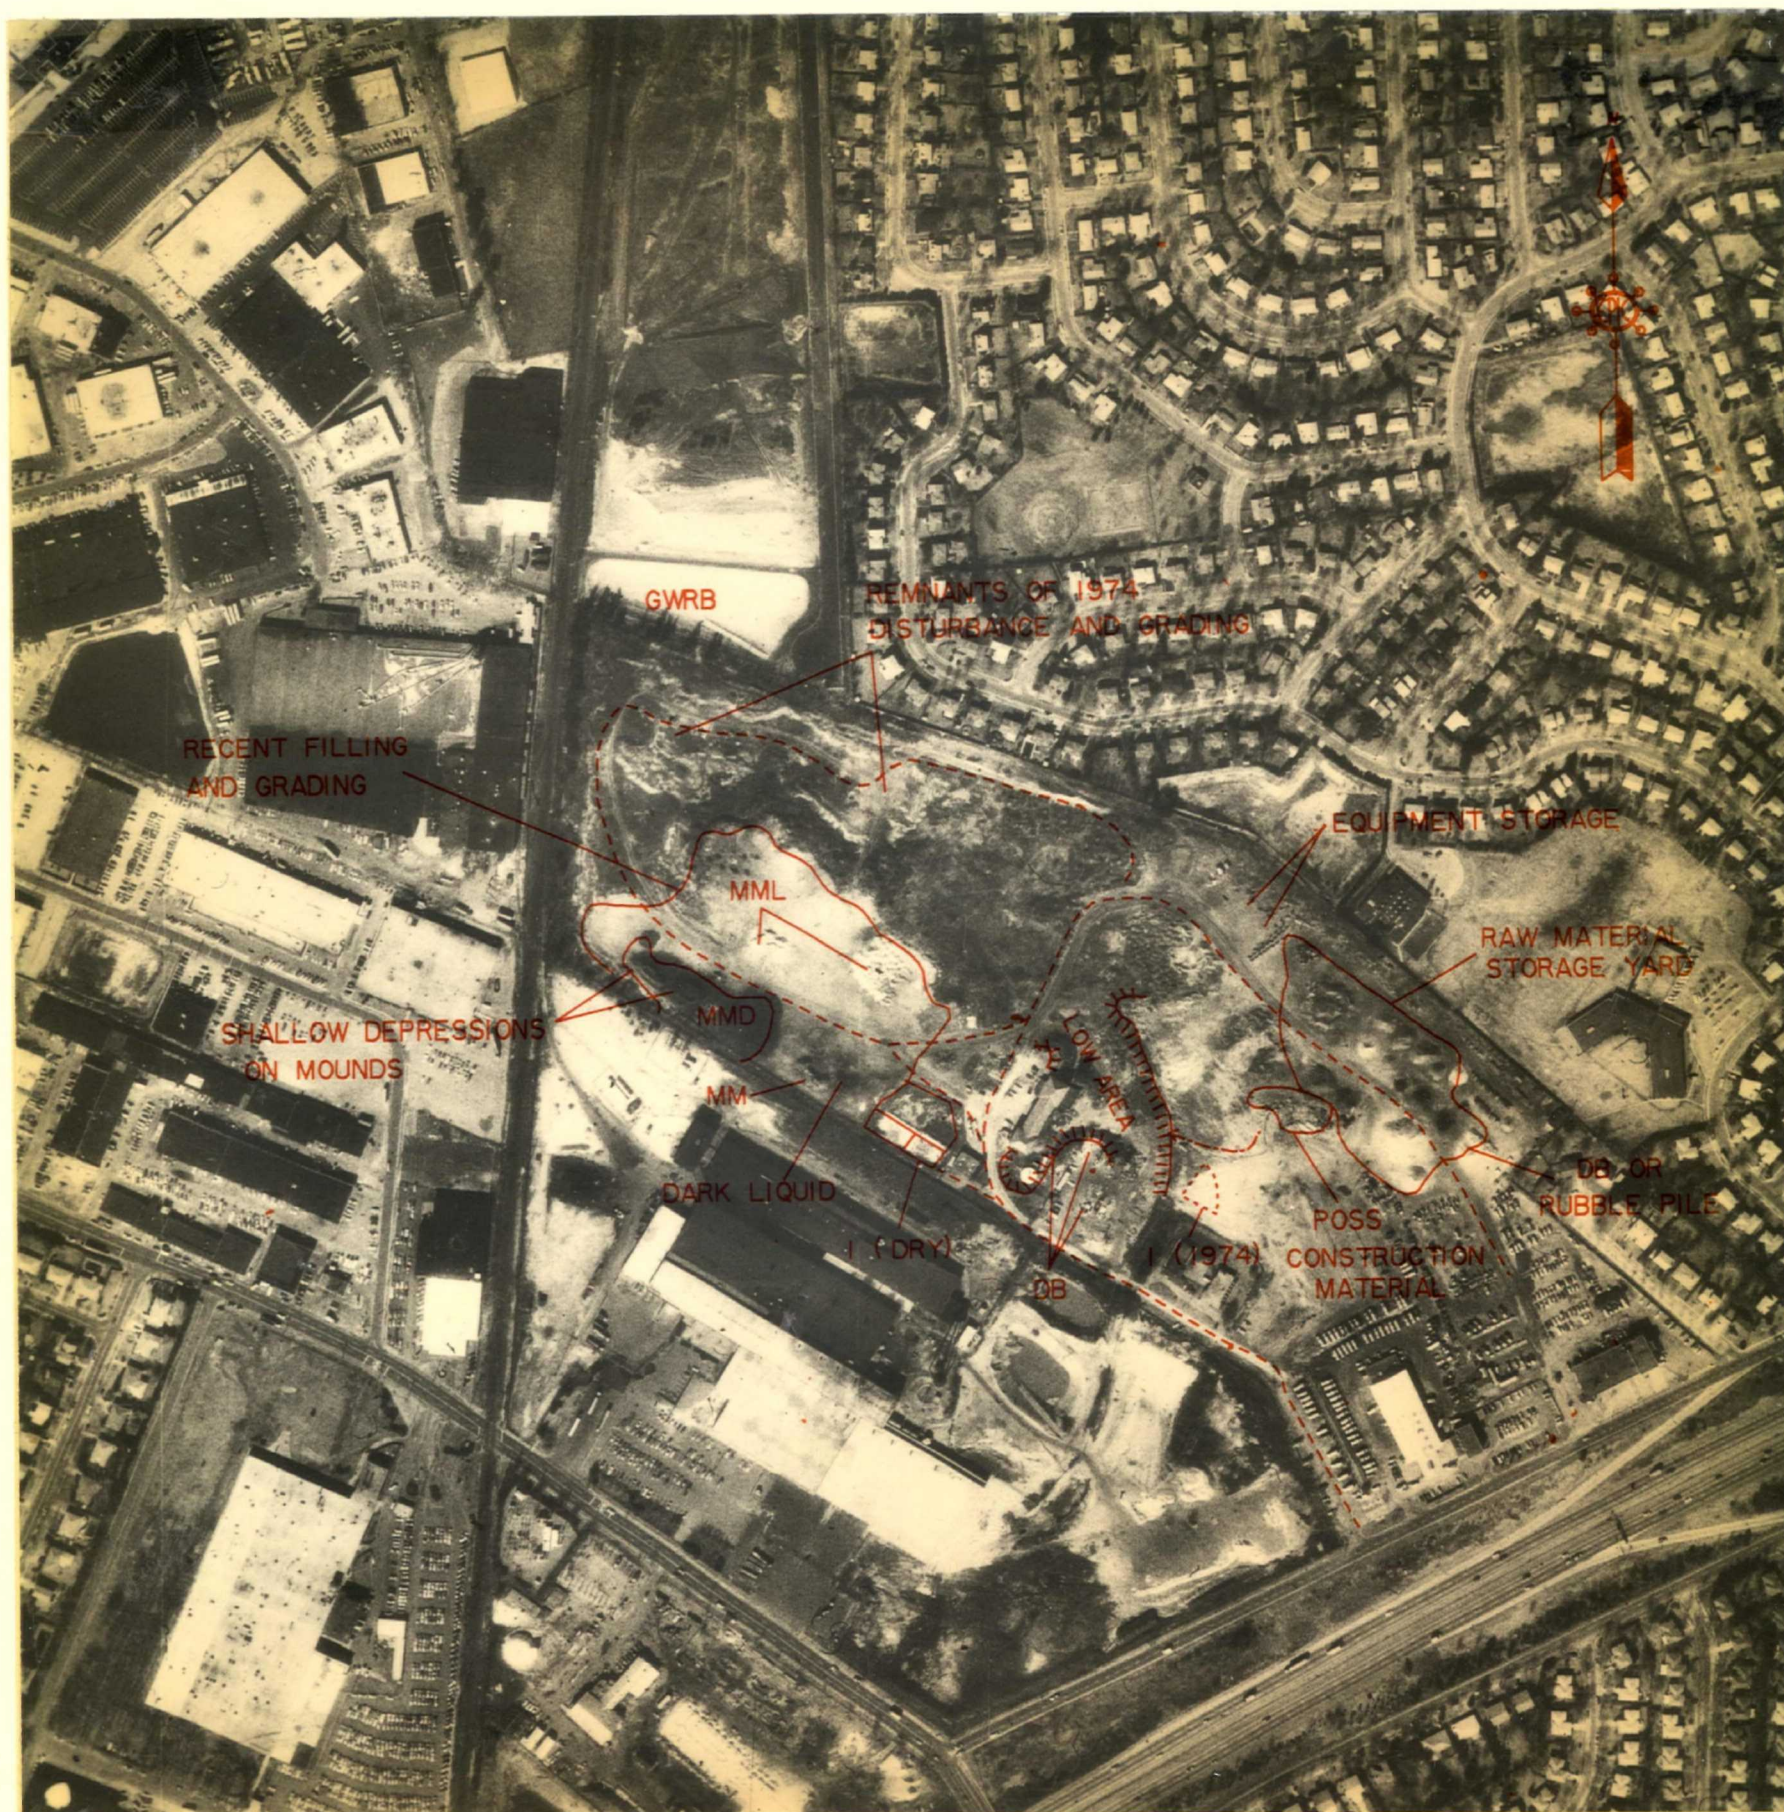
PHOTO 13 SYOSSET LANDFILL MARCH 6, 1980 APPROX SCALE 1:5,000

Recent landfilling and grading activity has occurred on approximately 2.5 hectares (6 acres) of the old fill area. Several piles of mounded light-toned and dark-toned material (MML and MMD) are present in the recently graded area. The dark material has shallow depressions on top of the mounds. Other mounds of material (MM) and dark standing liquid can be seen to the east. The sectioned impoundment (I) located along the southern edge of the site is dry in 1980. Debris (DB) can be seen east of the old incinerator building.

Equipment and raw material storage are found in the east portion of the landfill. Possible construction material and related equipment are also stored in this section of the landfill. A drainage ditch leads from this area of construction material to the low area northeast of the incinerator. The impoundment (I) first seen in 1974 has been completely filled by 1980.

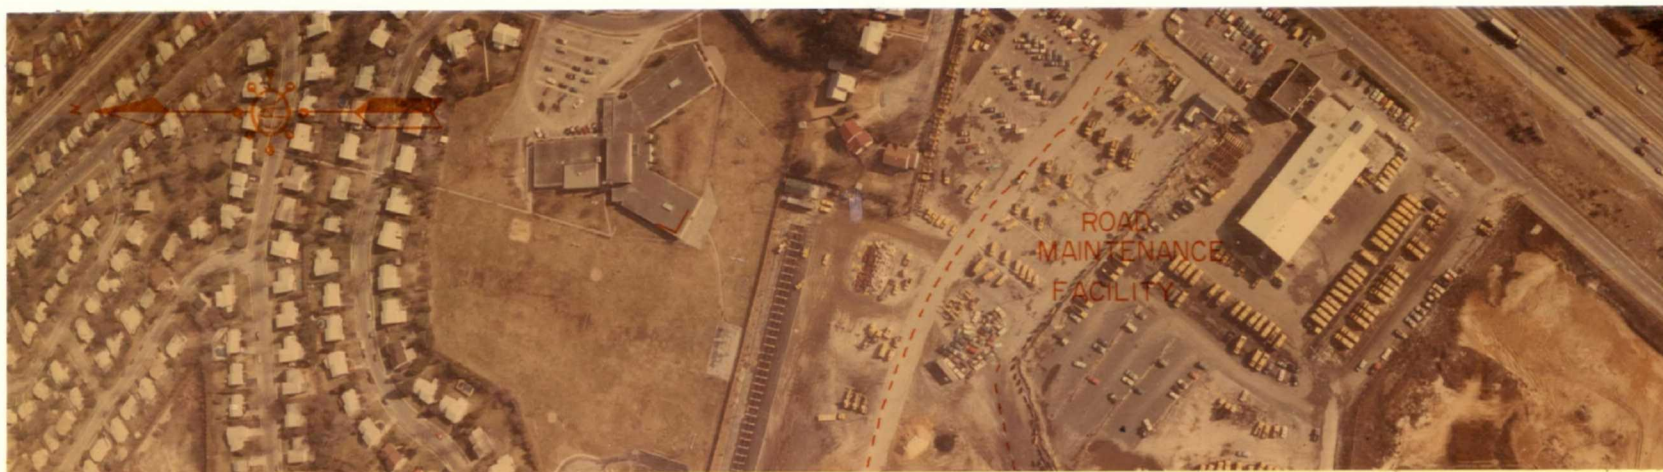
PHOTO 14 SYOSSET LANDFILL FEBRUARY 1, 1983 APPROX SCALE 1:3,200

Several large rusted tanks are located next to the northern wall of the landfill site. Rust-colored liquid (probable leachate) can be seen southwest of these tanks.

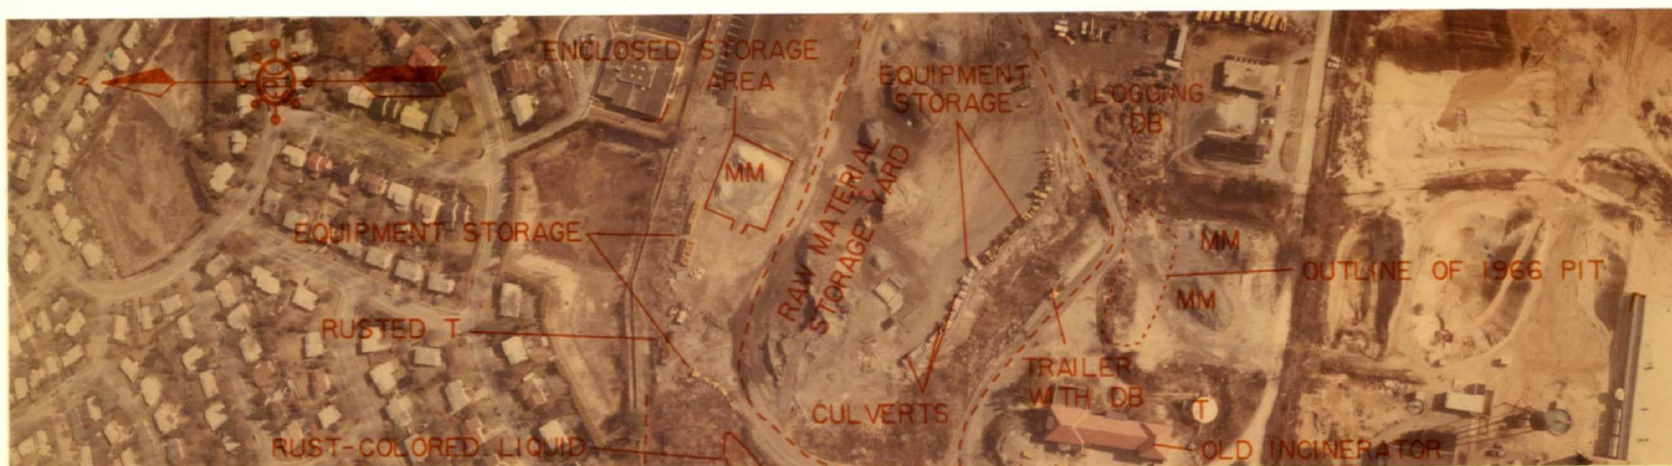
PHOTO 15 SYOSSET LANDFILL FEBRUARY 1, 1983 APPROX SCALE 1:3,200

Logging debris (DB) can be seen at the southeastern edge of the landfill (Photo 15). Debris is spilling out the back of a trailer along the access road that leads from the raw material storage area onto the western portion of the landfill. The outline of the pit seen in 1966 is annotated to the south. Two mounds of greyish material (MM) are located adjacent to the filled 1966 pit. Also pictured on Photo 15 are the old incinerator and the tank (T) located next to it. Several yellow trucks and passenger cars are parked in the parking area next to the incinerator.

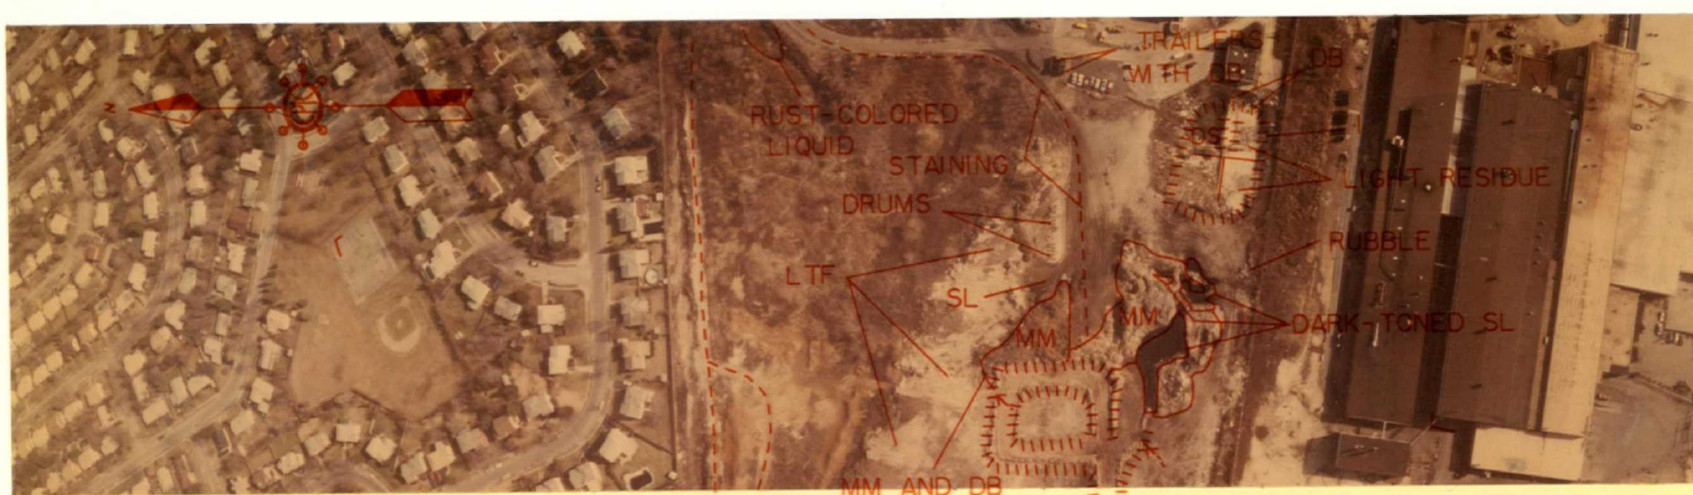
PHOTO 16 SYOSSET LANDFILL FEBRUARY 1, 1983 APPROX SCALE 1:3,200

Photo 16 shows the eastern portion of the old western fill area. The four-sectioned impoundment (I) first seen in 1969 is still visible. Dark staining (DS) is evident in the northeast section; white residue is visible in the other sections. Debris (DB) has been dumped down the side of the impoundment into the two easternmost sections. Staining can be seen along the access road that leads from the incinerator onto this portion of the landfill. Lines of drums can be seen on a light-toned area adjacent to the access road which leads to a pile of mounded material (MM) and debris (DB) (including many uniformly shaped objects). An area of standing liquid (SL) abuts this mounded material. Several areas of light-toned fill (LTF) have been spread north of this mounded material. Additional mounded material (MM) and very dark standing liquid (SL) (possible liquid waste) can be seen south of this mound.

A rectangular revetted area is also present in this area. The revetments form a rectangular loop that is accessed from the west by a revetted road. Two breaks in the revetment can be seen (annotated by arrows). An offshoot or section of the revetment leads directly to the mounded material and dark standing liquid mentioned above. The revetted entrance to this loop leads to the access road annotated on Photo 17 and curves back to the east to the raw material storage area seen in Photo 15. Brown mounded material (MM) can be seen near the entrance of this revetted loop (see Photo 17). Dark staining (DS), light-toned fill (LTF), rubble, and debris (DB) can be seen to the north.
